# Measuring Streambank Erosion: A Comparison of Erosion Pins, Total Station, and Terrestrial Laser Scanner

Annis Water Resources Institute, Grand Valley State University, 740 W. Shoreline Dr., Muskegon, MI 49441, USA

**Abstract:** Streambank erosion is difficult to quantify; models and field methods are needed to assess this important sediment source to streams. Our objectives were to (1) evaluate and compare three techniques for quantifying streambank erosion: erosion pins, total station, and laser scanning, (2) spatially assess streambank erosion rates in the Indian Mill Creek watershed of Michigan, USA, and (3) relate results with modeling of nonpoint source pollution. We found large absolute and relative errors between the different measurement techniques. However, we were unable to determine any statistically significant differences between techniques and only observed a correlation between total station and laser scanner. This suggests that the three methods have limited comparability and differences between measurements were largely not systemic. Further, the application of each technique should be dependent on site conditions, project goals, desired resolution, and resour

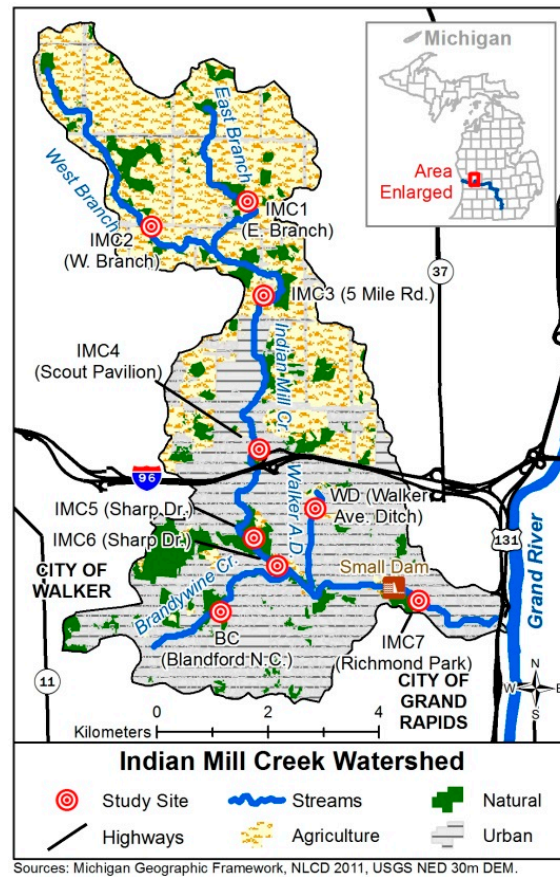
**Figure 1.** Study area map of the Indian Mill Creek watershed with features, land cover, and sites.

Nine sites were chosen for this study (Figure 1). Four sites were in the lower urbanized reaches of Indian Mill Creek, three sites were in the upper farmland, and two sites were on small urbanized tributaries. Sites are labeled with name and left (L) or right (R) bank and are ordered from lowest reach (IMC7) to headwaters (IMC1), followed by the small tributary sites (BC and WD). Sites were chosen to be dispersed around the watershed and where permission for access was obtained by landowners. For each site, an 18 m section of stream was chosen, based on a balance between an open channel for laser scanning and being representative of the reach, and then split into the left and right banks while looking downstream. Erosion pins were installed at all eighteen banks, total station surveys were performed at sixteen, and laser scanning was performed at ten. The presence/absence of undercut banks and heavy vegetation at each bank was also noted.

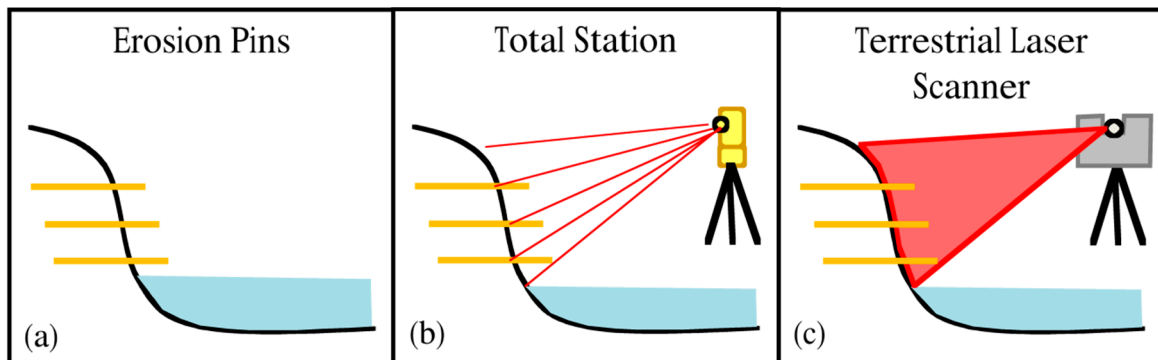
**Figure 2.** Deployment of (a) erosion pins, (b) total station, and (c) terrestrial laser scanner showing vertical profile of streambank.

A total of 137 erosion pins were installed at the eighteen banks following the design of prior studies [5,11,27]. The erosion pins were of 2' × 0.5" rebar pieces. Prior to installing erosion pins, the 18 m stream section was divided into three six-meter subsections using a measuring tape. Erosion pins were carefully installed in the middle of each subsection on both banks. One to three pins were installed at each location evenly spaced up the bank, with one pin for approximately every meter of bank height (Figure 2). Extra pins were installed if there were visible changes not captured by the design, such as the vertical transition between an undercut bank and vegetated slope. The average number of erosion pins deployed along the longitudinal 18 m study streambanks was 7.3, with a minimum of 4 and maximum of 20 pins per bank. Thus, the erosion pins had the lowest resolution of the three techniques.

Erosion pins were measured from tip of the pin to streambank using a measuring tape to the nearest 0.5 cm. The average of measurements from the top and bottom of the pin was used to account for bank slope. Where there was a longitudinal (horizontal) angle to the bank, the left and right sides of the pin were also included in the average. Erosion pins were measured monthly from May to September 2017, with two additional measurements following rain storms, then April to May 2018. The spread of erosion pin data at each site was analyzed using R3.3.2 [28]. The volume of soil loss per meter of stream length for each bank was estimated following methods of Palmer [29] and Zaimes et al. [30], by multiplying the average erosion pin value by the bank height, which we estimated as a uniform height from total station data. Overall change in bank volume was estimated by multiplying this rate by the 18 m site length.

A Topcon GPT-3107 W total station theodolite on tripod with Spectra Precision SurveyPro software (Spectra Geospatial, Westminster, CO, USA) was used to survey streambanks in May 2017 and May 2018. The instrument was set on one of the control points and backsighted to the farthest point for the most accurate orientation. When the instrument needed to be moved, a temporary control point was created by pushing a marker into the ground, and the previous point was checkpointed to determine error during movement. A reflector prism was used on top of a staff with bubble level to collect points. Using this prism, the stated accuracy of the instrument was 3 mm. For undercut banks, the horizontal distance between the prism staff and the back of the undercut was noted. However, data for undercut banks were not incorporated into erosion estimates because virtual models could not account for overhanging bank shape.

The site design for the total station surveys was based on methods of Keim et al. [13] and Resop and Hession [9]. Seven transects were performed along each bank over the 18 m site, at the 0, 3, 6, 9, 12, 15, and 18 m marks. The 3, 9, and 15 m marks coincided with erosion pin locations. In each transect, sideshots for the top of the bank and toe were collected. Then, two to three shots were taken evenly spaced along the bank, depending on its size and variability (Figure 2). These shots were taken at erosion pins during the 3, 9, and 15 m transects, at the location where the pin met the streambank. The total station had an average of 35 measurement points per streambank (min = 23, max = 52), so collected higher resolution data than the erosion pins in this study.

One to both banks were surveyed at each site with a FARO Focus3D terrestrial laser scanner in May 2017 and a Trimble TX8 scanner in May 2018 (Figure 2). The stated ranging accuracies of

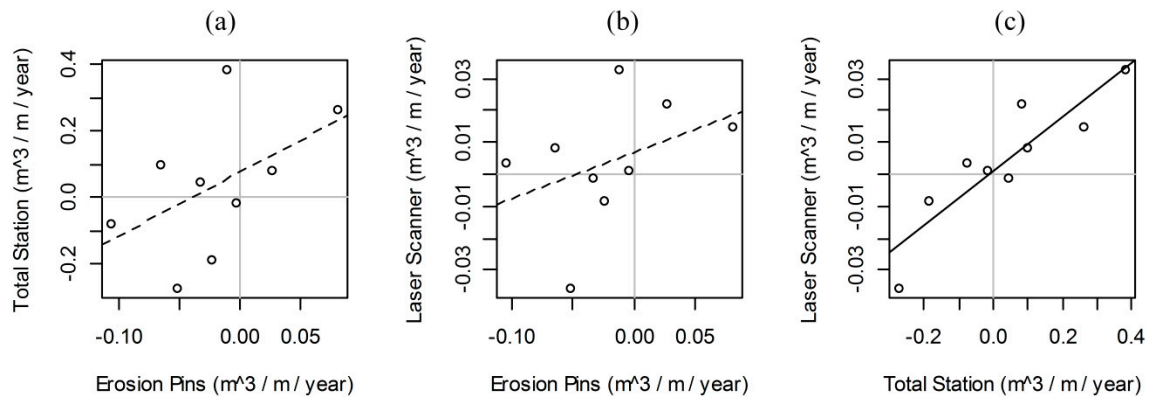
**Figure 3.** Correlations of bank volume change rate estimates between (a) erosion pins and total station ( $R = 0.51$ ,  $p = 0.330$ ), (b) erosion pins and laser scanner ( $R = 0.40$ ,  $p = 0.330$ ), and (c) total station and laser scanner ( $R = 0.89$ ,  $p = 0.003$ ) for nine sites in the Indian Mill Creek watershed. Solid line indicates significant correlation.

The ANOVA showed that there were no detectable differences between streambank erosion measurement techniques ( $df = 2/23$ ,  $F = 0.457$ ,  $p = 0.639$ ). Correlation tests found no significant correlations between erosion pin and total station data ( $R = 0.51$ ,  $p = 0.330$ ) or erosion pin and laser scanner data ( $R = 0.40$ ,  $p = 0.330$ ; Figure 3). However, there was a significant correlation between total station and laser scan data ( $R = 0.89$ ,  $p = 0.003$ ). These correlations show how measurements are related, but do not indicate which is more accurate.

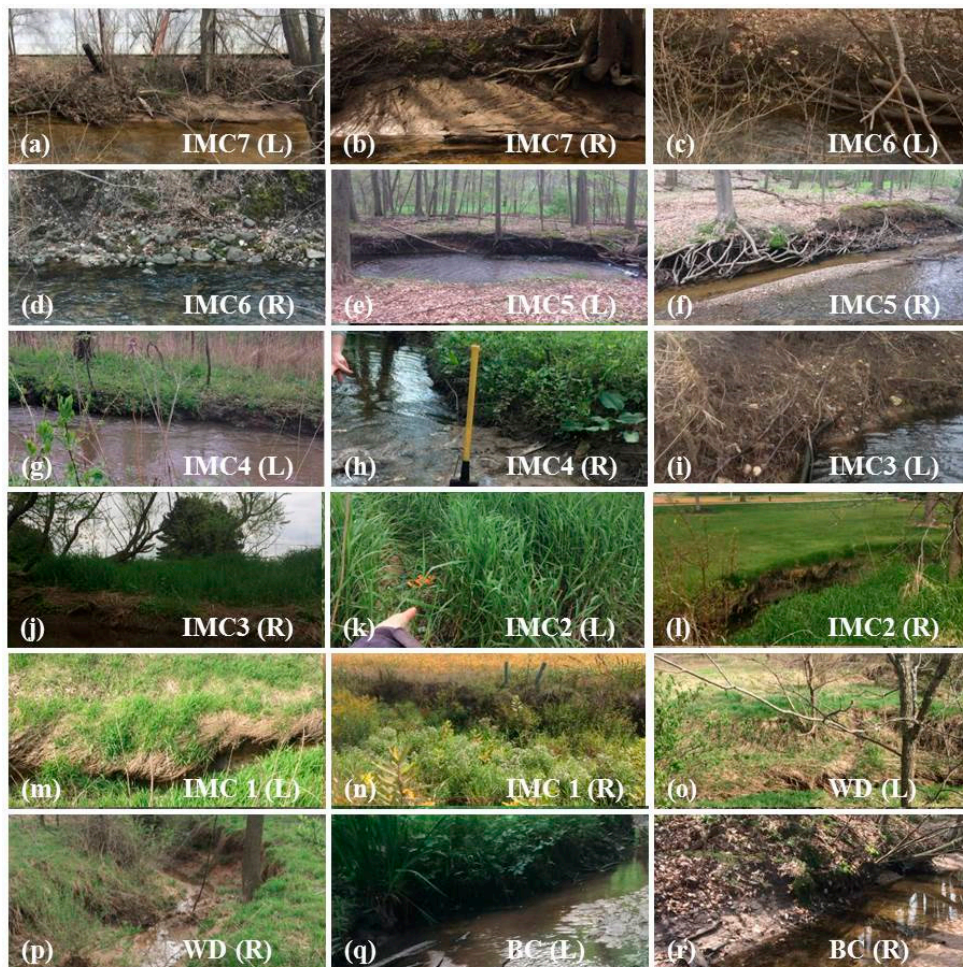
**Figure 4.** Photos of the 18 study streambanks in the Indian Mill Creek watershed, labeled by figure letter, site and left (L) or right (R) bank. Photos (a) through (h) are in the lower watershed through urban and forested land cover, (i) through (n) are in the upper watershed through farmland, and (o) through (r) are on tributaries.

At both IMC5 banks, the laser scanner documented very little change in bank volume, even though there was substantial undercutting and slumping along both banks (Figure 4e,f), documented by erosion pins. The total station estimate was consistent with erosion pin data (26% difference). However, for the IMC5 (R) bank, there was a 251% difference. A likely reason for the disparity is that the entire right bank was undercut and the lip had been pushed up; erosion pins were still able to collect data in the undercut, but the total station with was only able to collect data on the top of the bank.

At the IMC4 (L) bank, erosion pins measured slight erosion, while the total station estimated slight deposition. This difference could once again be the undercuts that extend the entire length (Figure 4g). Reduced laser scan coverage from roots and vegetation (0.5%) likely explains the low estimate of bank change from the laser scanner. The IMC4 (R) bank had a disparity where the total station measured heavy sediment deposition, but the erosion pins only measured slight deposition. This could be because erosion pins are limited in their ability to measure localized sediment deposition (Figure 4h).

Agricultural sites in the upper watershed primarily experienced bank erosion. The IMC3 site had substantial bank erosion measured by erosion pins along both banks (Figure 4i,j). At this site, a constricting culvert under a driveway, large willow fallen across the creek, and runoff from upstream farmland could be altering the local hydrology to scour the banks. At the IMC2 site, the left bank had consistent measurements of bank change, showing slight erosion, although it is likely that the low estimates inflated the relative error between techniques (Figure 4k). This low erosion rate made sense because the site has a vegetated riparian buffer of approximately ten meters to protect the banks. Erosion pin and total station estimates for the IMC2 (R) bank both showed erosion. This bank was along a lawn with no riparian buffer and was visibly eroding (Figure 4l).

erosion pins had coarser data that could miss eroding areas. At the BC site banks, the erosion pins measured erosion, while to total station measured deposition. The laser scanner data on the right bank also showed deposition, but of lesser magnitude. We observed sediment deposition on the bed of Brandywine Creek and the toe of the banks at the BC site, as well as evidence of powerful flows during storms that pushed down grass in the creek's floodplain. Undercut banks could also explain why the total station estimated more deposition (Figure 4q,r).

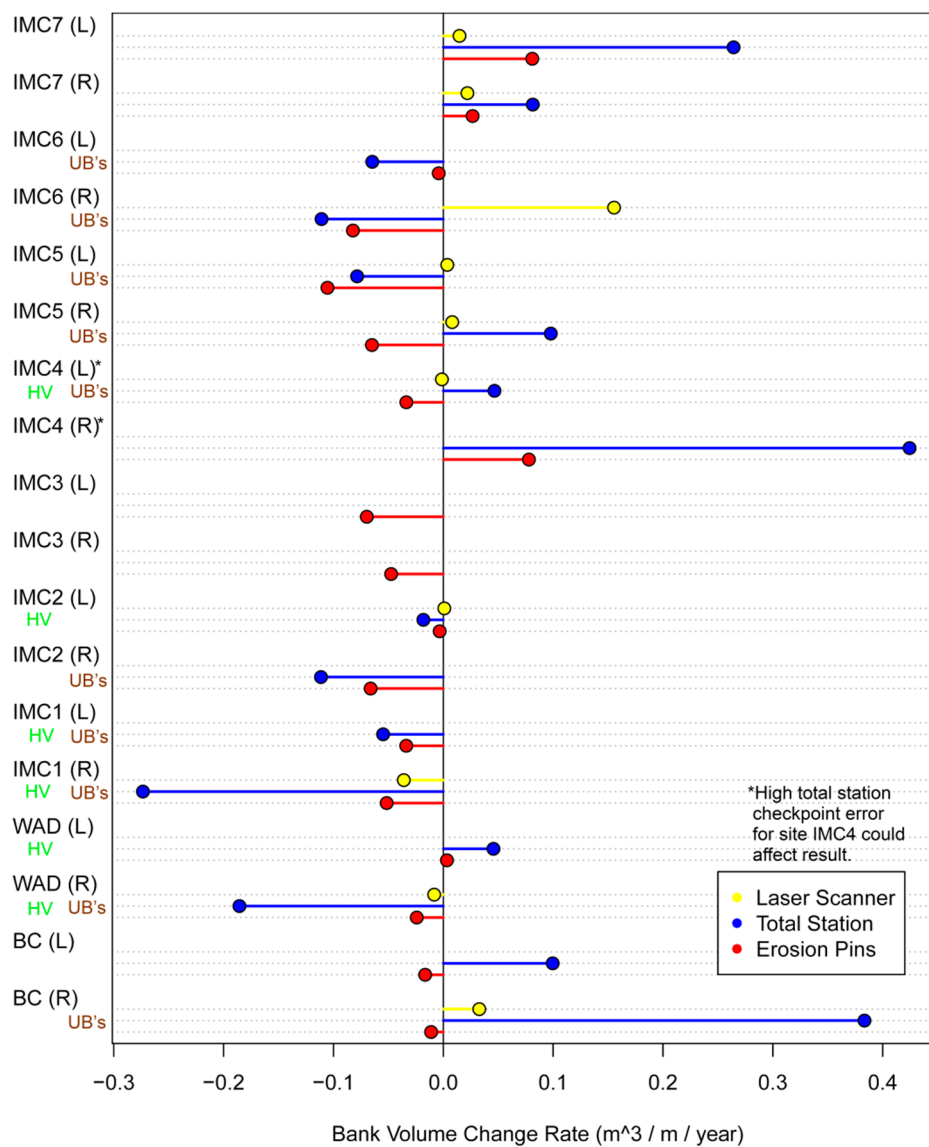
**Figure 5.** Comparison of results from techniques used to measure streambank erosion in the Indian Mill Creek watershed 2017–2018. Positive values indicate net deposition while negative values indicate net erosion being measured. Presence of heavy vegetation (HV) or undercut banks (UB's) is noted under site names to visualize the effects of these variables on estimates of bank volume change.

Study streambanks experienced net deposition (positive volume change), net erosion (negative), little change in bank volume (points near zero), or a mixture depending on the technique (Figure 5). Relative error between techniques were substantial, with an average difference of 650% between erosion pins and total station data, 596% between the laser scanner and erosion pins, and 1275% between the laser scanner and total station (Table 2).

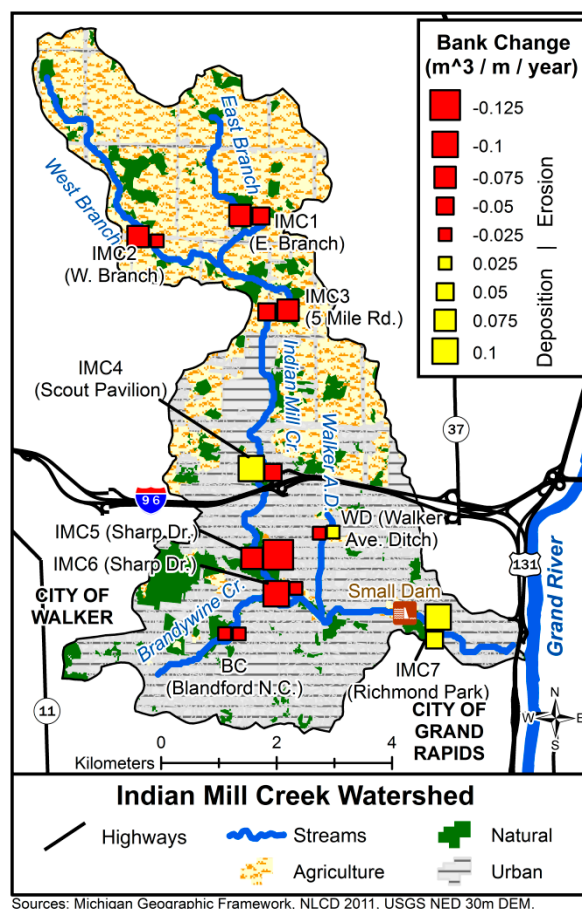
**Figure 6.** Spatial distribution of erosion (red) and deposition (yellow) rates for study streambanks using erosion pin results.

We assessed the spatial distribution of streambank erosion in the Indian Mill Creek watershed. The lower watershed experienced net deposition of sediment along the banks (Figure 6), as we noted while observing heavy sand deposition on the IMC7 banks. This 5 km section of the creek (up from the mouth) has a low average gradient of approximately 0.3%, which could explain why the stream channel is aggrading there as the creek loses power [34,35]. This could also be an impact of the urbanization in the watershed, which can increase hillslope erosion upstream and cause the stream channel to aggrade [2]. Two sites (IMC4 and WD) experienced alternating patterns of erosion and deposition at opposite streambanks in meander segments. Fluvial processes along bends caused the outer bank to erode while sediment was deposited along the inner bank [36]. Stream processes have been identified as the dominant mechanisms affecting streambank erosion rates in a temperate watershed, more so than land use, subaerial (e.g., freeze/thaw) processes, or longitudinal location in a stream network [37]. All other sites experienced net bank erosion and contributed to sediment loading in the Indian Mill Creek watershed. Erosion in the agricultural headwaters of the creek (IMC1 and IMC2) could be intensified by riparian vegetation clearing and hydrological alterations [1]. The highest rates of bank erosion from erosion pin data were at the IMC6 and IMC5 sites, which are along a higher (0.7%) gradient section of the creek as it descends the Grand River valley. The higher gradient increases the power of the creek to degrade the stream channel [34,35].
