A Stormwater History of Grand Valley State University and an Assessment of the Stream Quality of the Little Mac Ravine

**A Stormwater History of Grand Valley State
University and an Assessment of the Stream Quality of
the Little Mac Ravine**

**Christina Hamilton
HNR 499
August 2014
Grand Valley State University**

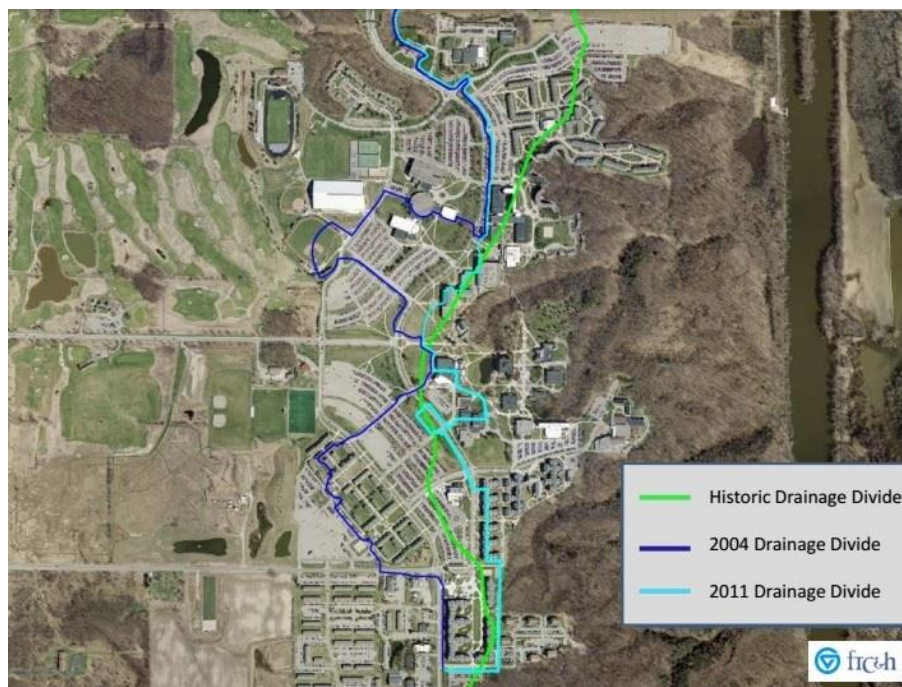
Figure 1.3 Aerial view of Grand Valley State University Allendale campus showing the original drainage before the university (green), how the drainage area changed by 2004 (dark blue), and how it changed again after the construction and utilization of wetlands (light blue; Kerri Miller, personal communication).

of impermeable surfaces, so that 13% of the campus was impervious (Womble 2006). Eventually, the addition of buildings and parking lots on the west side of campus altered the hydrology of the campus watershed so that a larger surface area drained stormwater into the ravines (Figure 1.3). By 2004 168.9 acres of the campus were impermeable and only 25% of the discharge into the Little Mac stream could be attributed to natural runoff (Womble 2006). It was around this time that GVSU realized the implications of the stormwater management practices that were in place.

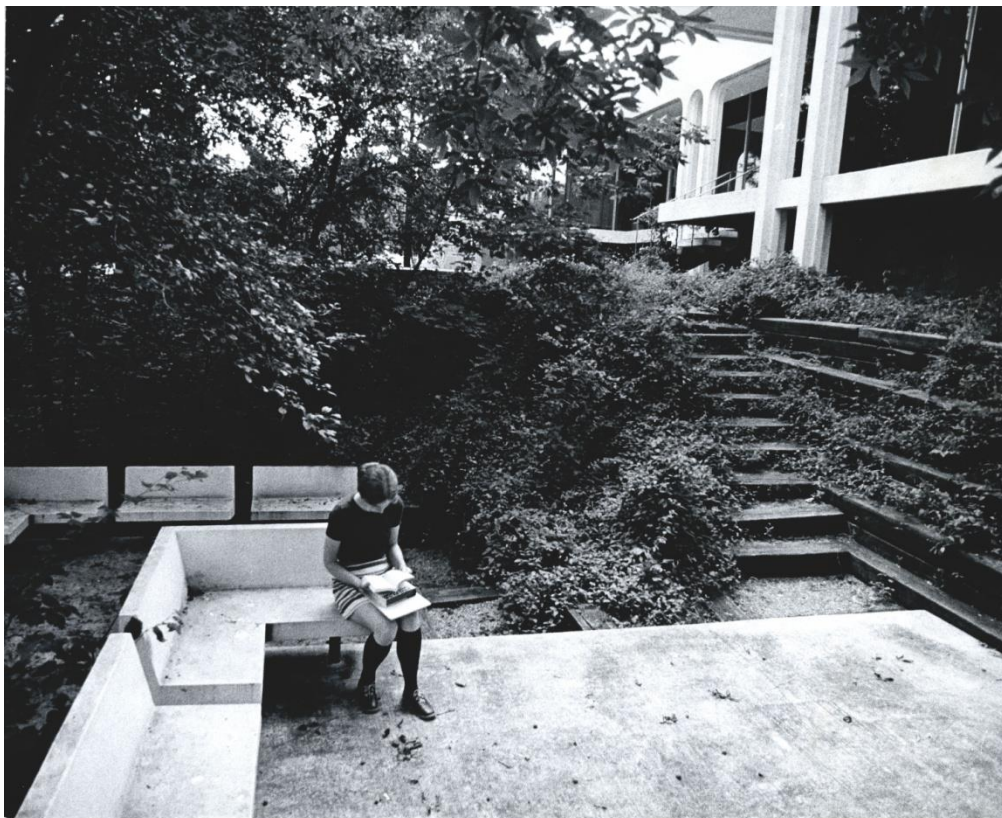
Figure 1.4 Student using the Seidman House outdoor study area, circa 1972 (Courtesy of GVSU University Archives). Due to slope failures the area became unstable and was removed in 2005.

patios that overlooked the ravines (Figure 1.4; James Moyer, personal communication). Slope failures in that area caused the patios to start leaning away from the building and resulted in their removal in 2005 (Nancy Richard, personal communication). On the north end of campus, a road for the Ravine Apartments was eighteen inches away from being lost due to slope failures. Other buildings, like the Seymour & Esther Padnos Hall of Science and Lake Ontario Hall, were threatened by slope failures. In response to the increasing problems associated with stormwater runoff, the Stormwater Advisory Group (SWAG), consisting of faculty and staff members, was founded in 2005 and a more environmentally friendly stormwater management strategy for GVSU was developed (Kerri Miller, personal communication; Womble 2006).

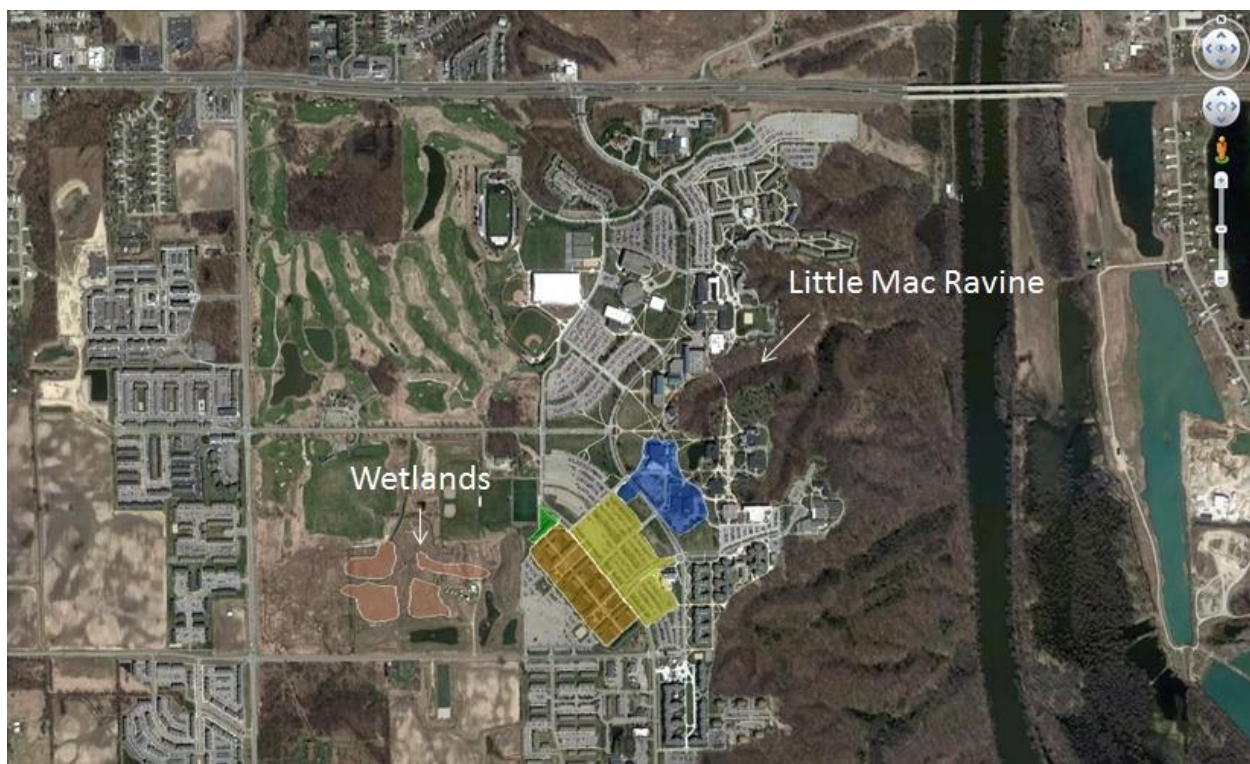
Figure 1.5 Aerial view of the constructed wetland complex (brown) and areas draining into the constructed wetlands (blue, green, yellow, and orange) post-diversion (Wampler and Kneeshaw 2013).

In 2011, a series of wetlands was constructed to accept stormwater from 32 acres of impervious surface the previously flowed to the ravines (Simonson et al 2011; Figure 1.5). It was expected that the wetlands would reduce the volume of stormwater entering the stream and allow a reduction of erosion in the streams and stabilization of the ravine slopes. Other discharge reduction practices implemented included rain gardens, porous asphalt parking lots, and green roofs (Table 1.1; Kerri Miller, personal communication). Stormwater management is also included in the planning of new buildings. Implementing stormwater management practices during building construction is much more cost effective than attempting to remedy damages and conduct retrofits after the building is completed.

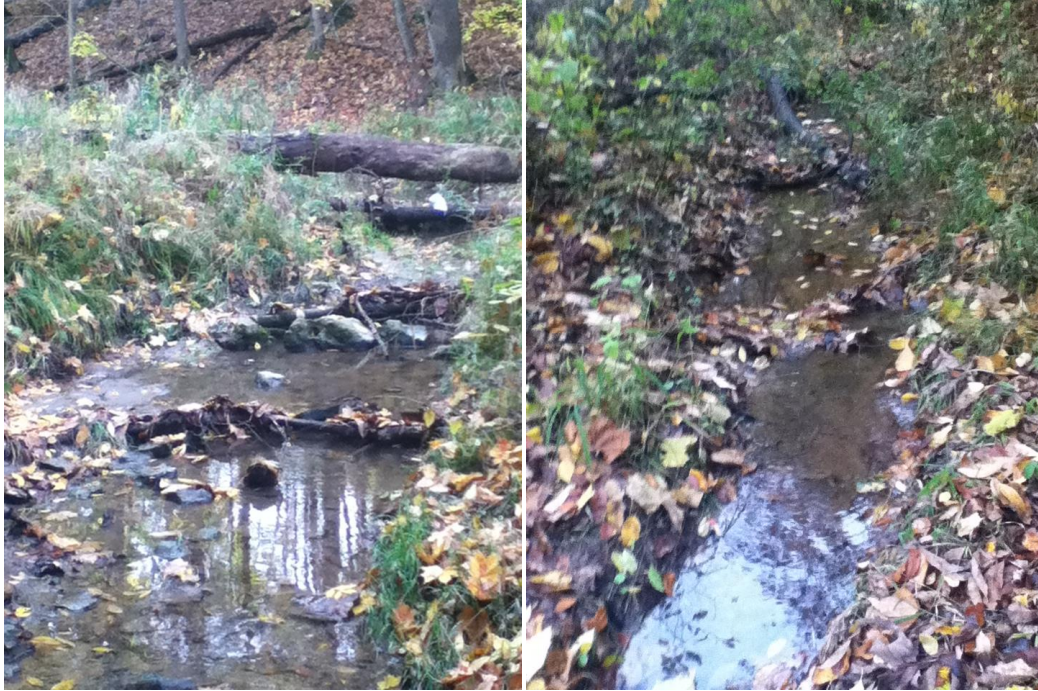
Figure 2.3 Sample location for the Little Mac stream in 2013 (left) was the same location sampled in 2008, and the control stream in 2013 (right).

Macroinvertebrates were sampled from the Little Mac stream and a control stream (Figure 2.2). The sample site in the Little Mac stream (Figure 2.3) was the same site used by Snyder et al (2008). The stream flows under the Little Mac bridge on the GVSU Allendale campus and drains into the Grand River. It is a small stream with widths varying from approximately 2-5 feet and depth ranging from a couple inches to a couple of feet. The sample location (N42.96532° W085.88363°) was chosen in 2008 for the presence of rocky substrate, as it is good habitat for macroinvertebrates. The watershed of the Little Mac stream is largely urbanized from development of the GVSU Allendale campus.

appears to be much less eroded than the Little Mac stream. The sample site of the control stream (N42.95128° W085.87582°) was chosen for its similar flow to the Little Mac stream sample location. Unfortunately, the site did not have a rocky substrate like the Little Mac stream, but rather more soft sediment and leafy material (Figure 2.3).
