Investigating Erosion and Ecological Impacts to an Urban Coldwater Stream Using Multiple Techniques

INVESTIGATING EROSION AND ECOLOGICAL IMPACTS TO AN URBAN
COLDWATER STREAM USING MULTIPLE TECHNIQUES

Master of Science in Biology

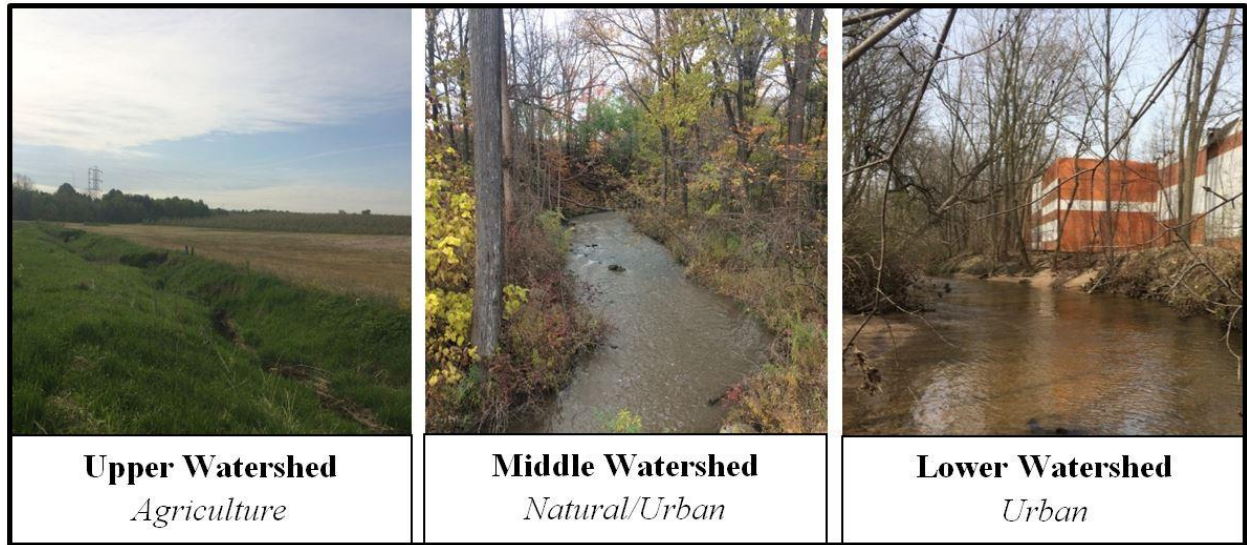
Figure 2.2. Photographs of the watershed’s agricultural to urban land cover gradient in Indian Mill Creek (2017).

Woody debris abundance was the strongest driver of healthy macroinvertebrate communities in Indian Mill Creek based on the CCA results. It was positively associated with abundance and richness of EPT. However, no sites met the representative condition for Midwest streams of 32.6 pieces per 100 meters (Cordova et al., 2007). Reduction was most evident in the agricultural headwaters where very few wood pieces were found. Deforested riparian zones and lack of mature trees in the headwaters (Figure 2.2) likely limit the amount of large woody debris

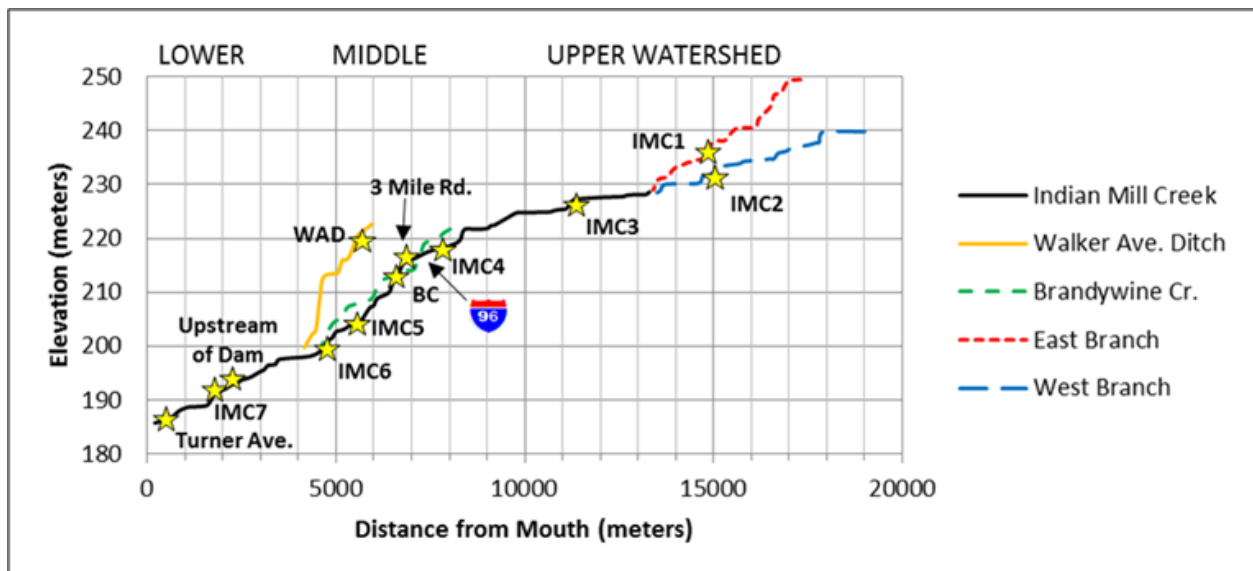
Figure 2.3. Indian Mill Creek and its tributaries following a topographical gradient (elevation data from Gesch et al., 2002). Stars indicate sampling sites.

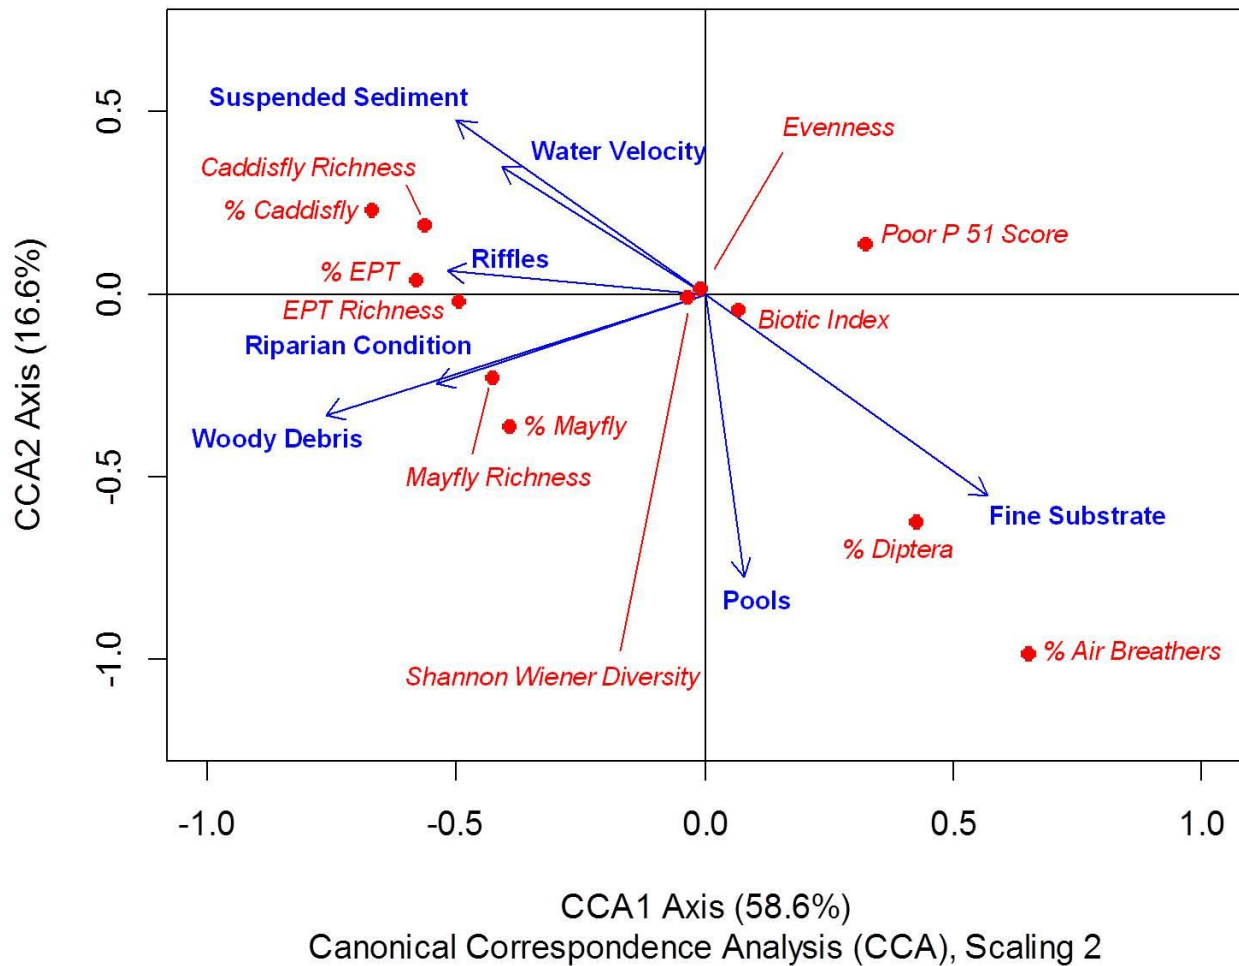
Figure 2.4. CCA Ordination showing the relationships between environmental stressors and macroinvertebrate metrics in Indian Mill Creek (2017).

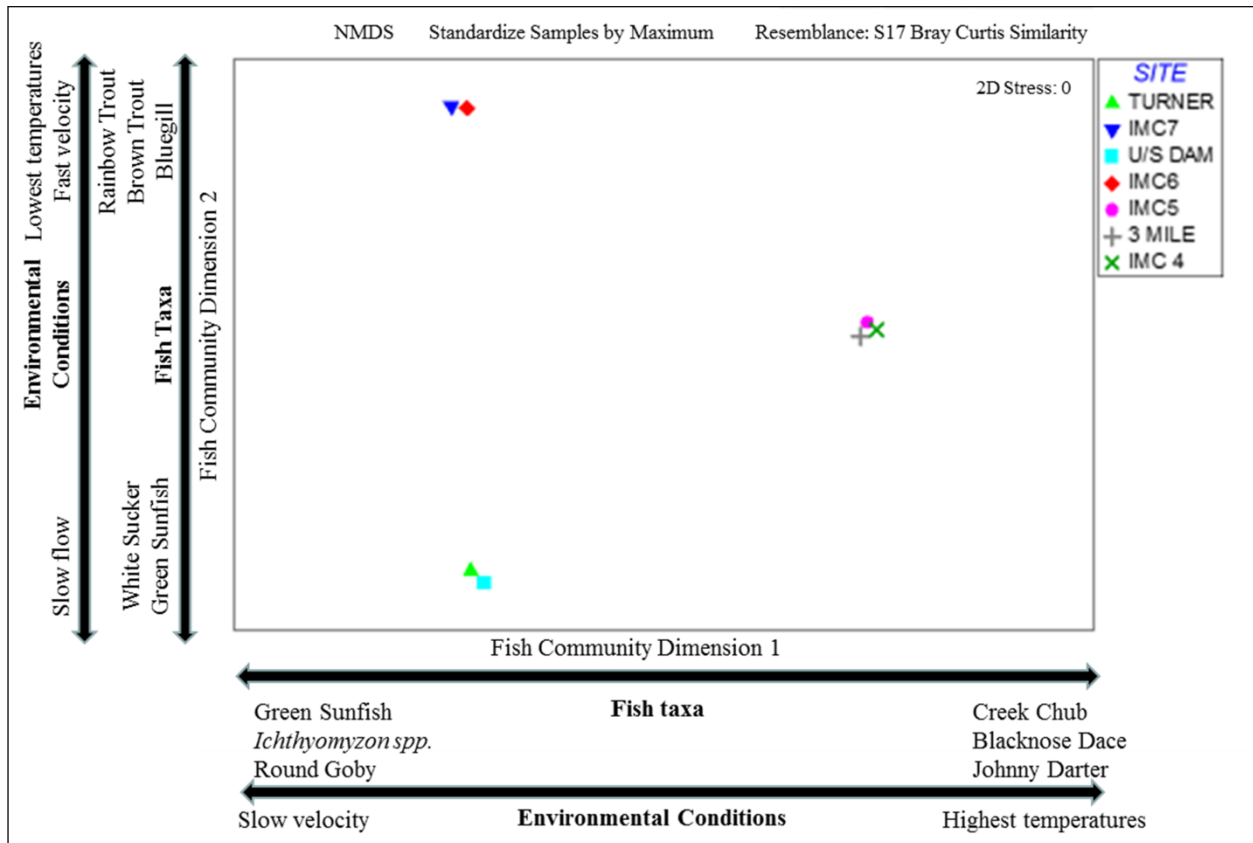
Figure 2.6. NMDS of fish communities in three distinct groups driven largely by stream temperature and flow regime in Indian Mill Creek (2017; A = 0.278, p = 0.009).

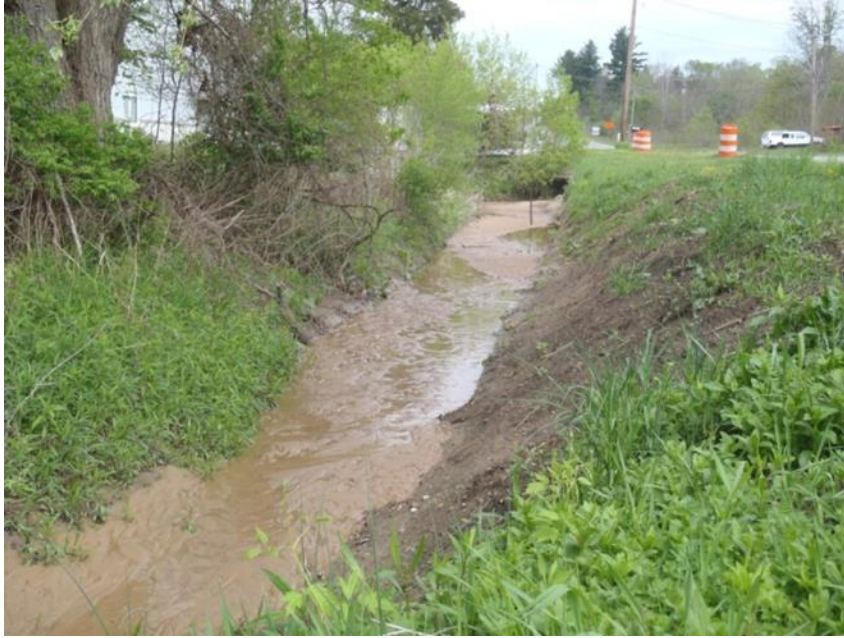
Figure 2.8. Habitat in the Walker Avenue Ditch (2017), visually degraded by excessive sand deposition (Sigdel, 2017).

The lower, urban reach had the largest amount of sediment bedload. This section has more gradual slopes because it is in the Grand River floodplain. However, channelization and high flows from runoff and impervious surfaces (Walsh et al., 2005b) counteract the flatter slope, increasing velocity and tipping Lane's Balance toward coarser substrate. Sigdel (2017) found that an increase in stream discharge from impervious surfaces in lower Indian Mill Creek caused banks to erode and moved large amounts of bedload sediment. Excessive bedload buries fish and macroinvertebrate habitat, causes fish populations to decline, and displaces macroinvertebrates (Alexander and Hansen, 1986; Culp et al., 1986; Sigdel, 2017). One of the sources of bedload is streambank erosion, which can be a major contributor of sediment pollution and is a source of sediment to Indian Mill Creek (Fox et al., 2016; Sigdel, 2017). Streambank erosion and sand deposition are evident in the watershed, especially in the Walker Avenue Ditch (Figure 2.8). Streambank erosion can be substantial in Indian Mill Creek, with lateral bank retreat of over 60cm documented in the middle watershed in a single summer (Sigdel, 2017).

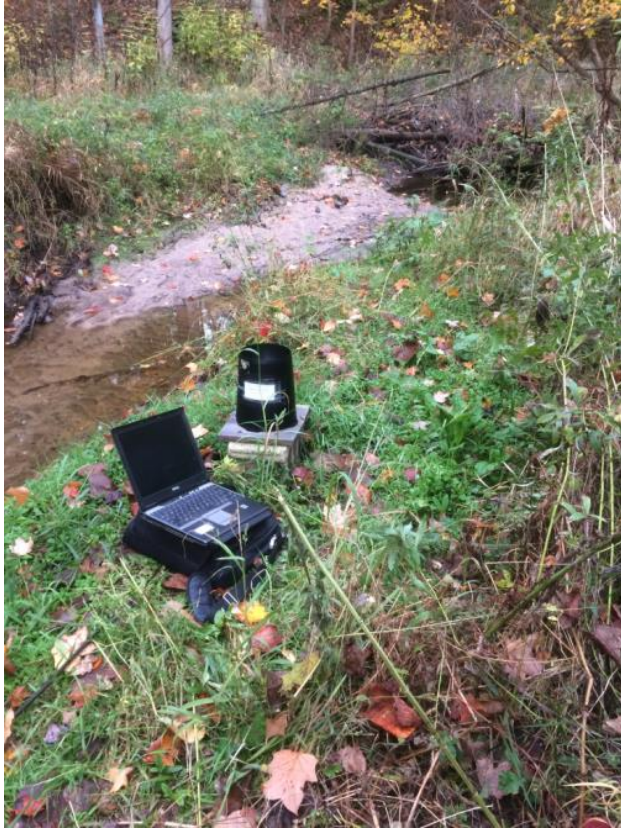
Figure 3.12. Flood-washed grass along Brandywine Creek in the Indian Mill Creek watershed, October 2017.

The Brandywine Creek area in the southwest portion of the watershed proportionally contributed the greatest amount of runoff to the creek, and the least amount of groundwater to feed base flow. A very low base flow in mid-summer and evidence of powerful floods after rain storms were observed in the adjacent grassy floodplain (Figure 3.12). This flow regime is likely caused by loamy soils of the C and D hydrologic groups with high runoff potential plus the high amount of urban development and impervious surfaces in the subbasin, which cause increased runoff and decreased infiltration of water to the soil (Paul and Meyer, 2001). Subbasin B21, the headwaters of Brandywine Creek, should be a priority for projects that capture runoff and increase infiltration of precipitation into the ground, followed by B19, B15, B13, and B16. This reduction in runoff is vital to restoration of the watershed; restoring stream habitat and riparian conditions in urban streams can be ineffective for recovery of aquatic life if the impacts of intense stormflows are not addressed (Walsh *et al.*, 2005). Low impact development guidelines are available to help plan these projects (Southeast Michigan Council of Governments, 2008). Suggested low impact development projects in these subbasins include a reduction in impervious surface area, bioretention basins, detention basins, pervious pavement, wetland conservation, floodplain avoidance, and vegetated swales.

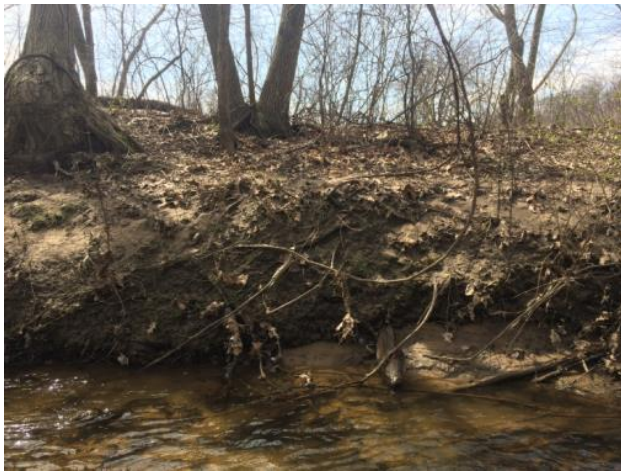
Figure 3.13. Sandy eroding banks observed in subbasin B12 in the lower Indian Mill Creek watershed, April 2017.

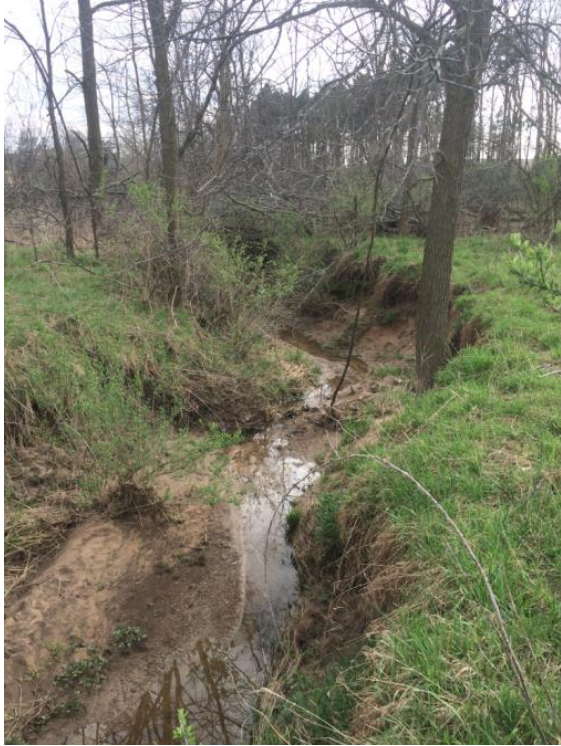
Figure 3.14. Severe incising and bank erosion observed in Walker Avenue Ditch (subbasin B11) of the Indian Mill Creek watershed, April 2017.

The GWLF-E didn't identify subbasin B11, the Walker Avenue Ditch, as a priority for streambank erosion. However, we have observed severe erosion occurring in B11 along with intensive sedimentation in the streambed, which appears to be among the worst in the Indian Mill Creek watershed (Figure 3.14). A concurrent study by the authors at nine sites in the Indian Mill Creek watershed will provide measurements of streambank erosion rates over the course of one year, May 2017 to May 2018, for a site in the Walker Avenue ditch and eight other sites in the Indian Mill Creek watershed. The purpose of this concurrent study is to compare four techniques for measuring streambank erosion: erosion pins, total station surveying, terrestrial laser scanning, and photogrammetry. The results will provide an empirical assessment of streambank erosion patterns in the watershed and see if it agrees with the upstream-downstream pattern of the GWLF-E model.

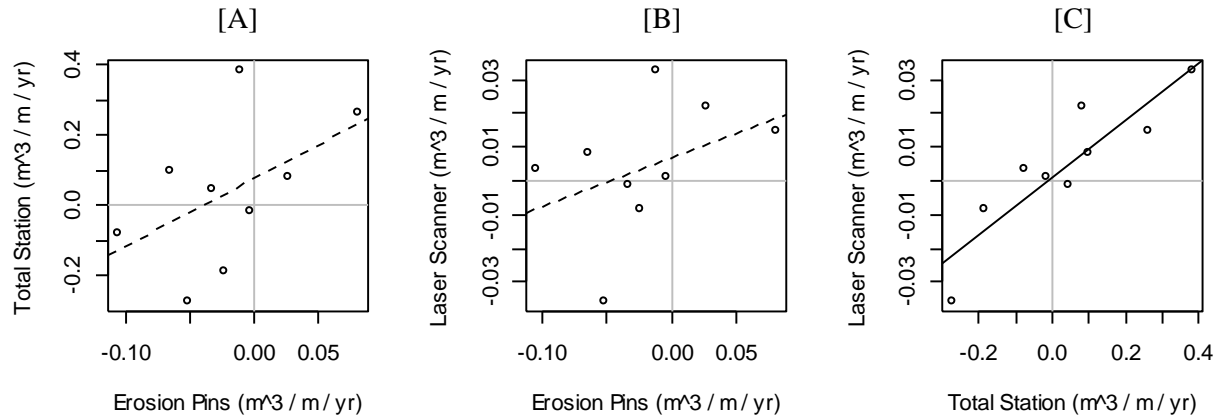
Figure 4.2. Correlations of bank volume change rate estimates between [A] erosion pins and total station ($R^2=0.26$, $p=0.330$), [B] erosion pins and laser scanner ($R^2=0.16$, $p=0.330$), and [C] total station and laser scanner ($R^2=0.79$, $p=0.003$) for nine sites in the Indian Mill Creek watershed. Solid line indicates significant correlation.

The ANOVA showed that there were no detectable differences between streambank erosion measurement techniques ($df=2/23$, $F=0.457$, $p=0.639$). Correlation tests found no significant correlations between erosion pin and total station data ($R^2=0.26$, $p=0.330$) or erosion

pin and laser scanner data ($R^2=0.16$, $p=0.330$; Figure 4.2). However, there was a significant correlation between total station and laser scan data ($R^2=0.79$, $p=0.003$).

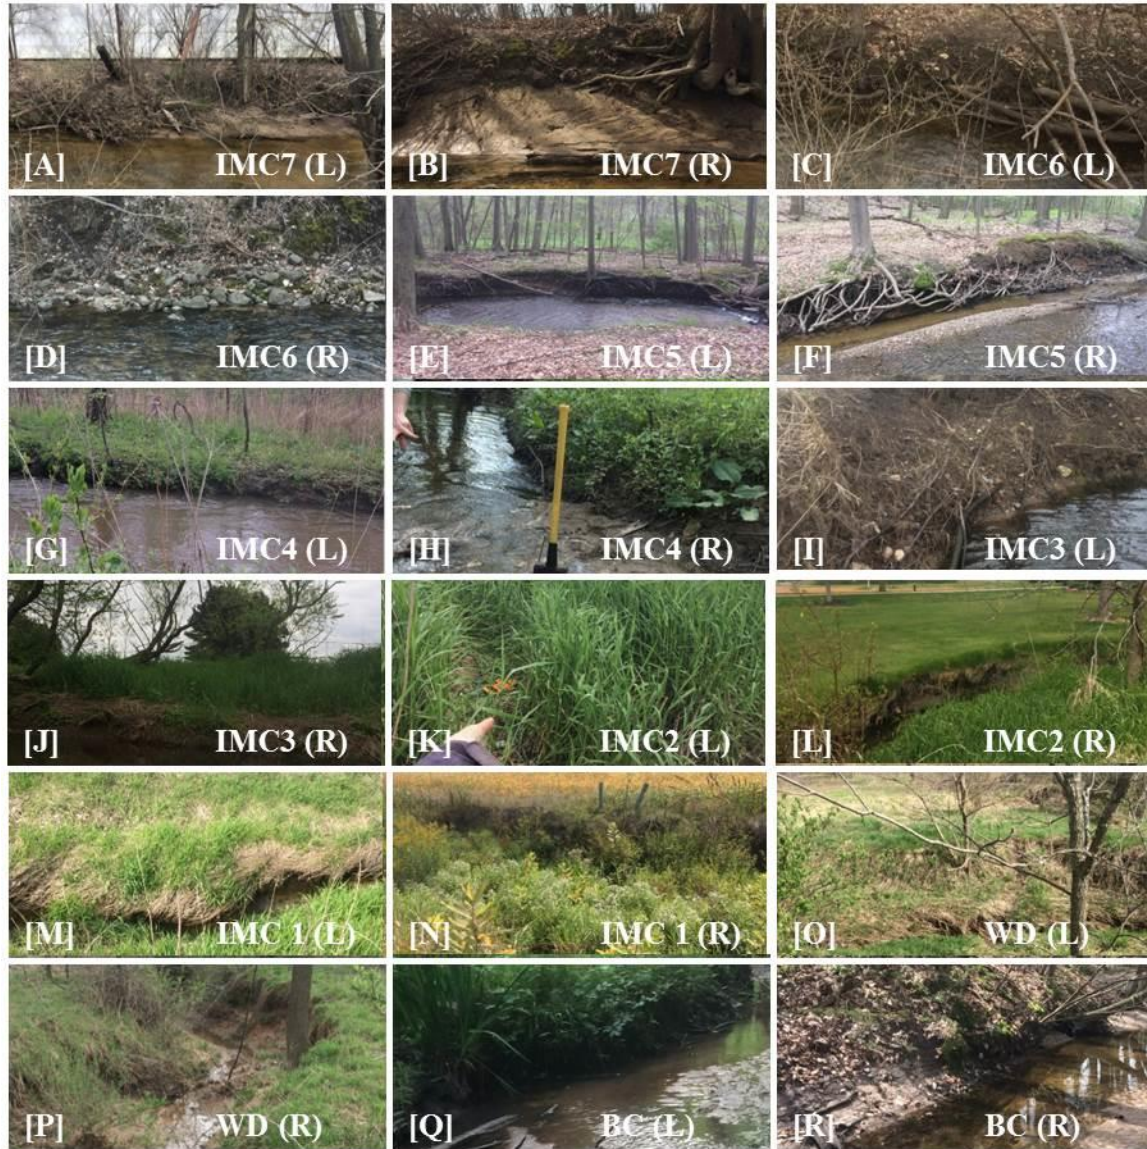
Figure 4.3. Photos of the 18 study streambanks in the Indian Mill Creek watershed, labeled by figure letter, site name and left (L) or right (R) bank. Photos [A] through [H] are in the lower watershed through urban and forested land cover, [I] through [N] are in the upper watershed through farmland, and [O] through [R] are along tributaries.

The dot chart shows that study streambanks experienced net deposition (positive volume change), net erosion (negative), little change in bank volume (points near zero), or a mixture depending on the technique (Figure 4.4). Sites are labeled with name and left (L) or right (R) bank and are ordered from lowest reach (IMC7) to headwaters (IMC1), followed by the two tributary sites. The presence of heavy vegetation (HV) or undercut banks (UB's) is noted under the site name to visualize the effects of these conditions on estimates of bank volume change. The following analysis of the chart is split into lower watershed, upper watershed, and tributary sites. Percent differences between techniques were substantial, with an average difference of 650% between erosion pins and total station data, 596% between the laser scanner and erosion pins, and 1,275% between the laser scanner and total station (Table 4.2). Bank photos are presented for reference in Figure 4.3.

Small tributaries in the watershed experienced a mixture of erosion and deposition. The WD site was along a meander, which explains why the left bank inside the bend had measured deposition, while the right bank on the outside of the bend had measured erosion (Figure 4.3 O and P). The total station could have estimated more erosion for the WD (R) bank than the pins and laser scans (differences of 668% and 2,136%) because the laser scans had data gaps, likely due to shrubs and herbaceous vegetation that got in the way, and because the erosion pins had lower resolution data that could have missed eroding areas. The BC site banks had erosion from the pin data, but substantial deposition estimated by the total station. The laser scan on the right bank showed minor deposition. We observed deposition of sediment on the bed of Brandywine Creek and the toe of the banks at the BC site during the study, as well as evidence of powerful flows during storms that pushed down grass in the floodplain (Figure 4.5). Undercut banks could also explain why the total station estimated more deposition and increased volume of the banks (Figure 4.3 Q).

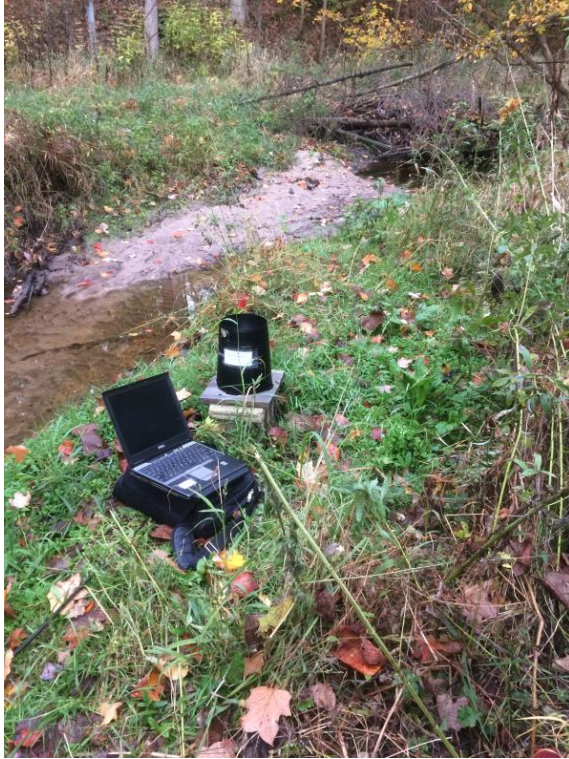
Figure 4.5. Evidence of high flows in Brandywine Creek floodplain in the Indian Mill Creek watershed, with rain gauge in foreground.
